Bathing Water Profile for Dores

Dores, Scotland

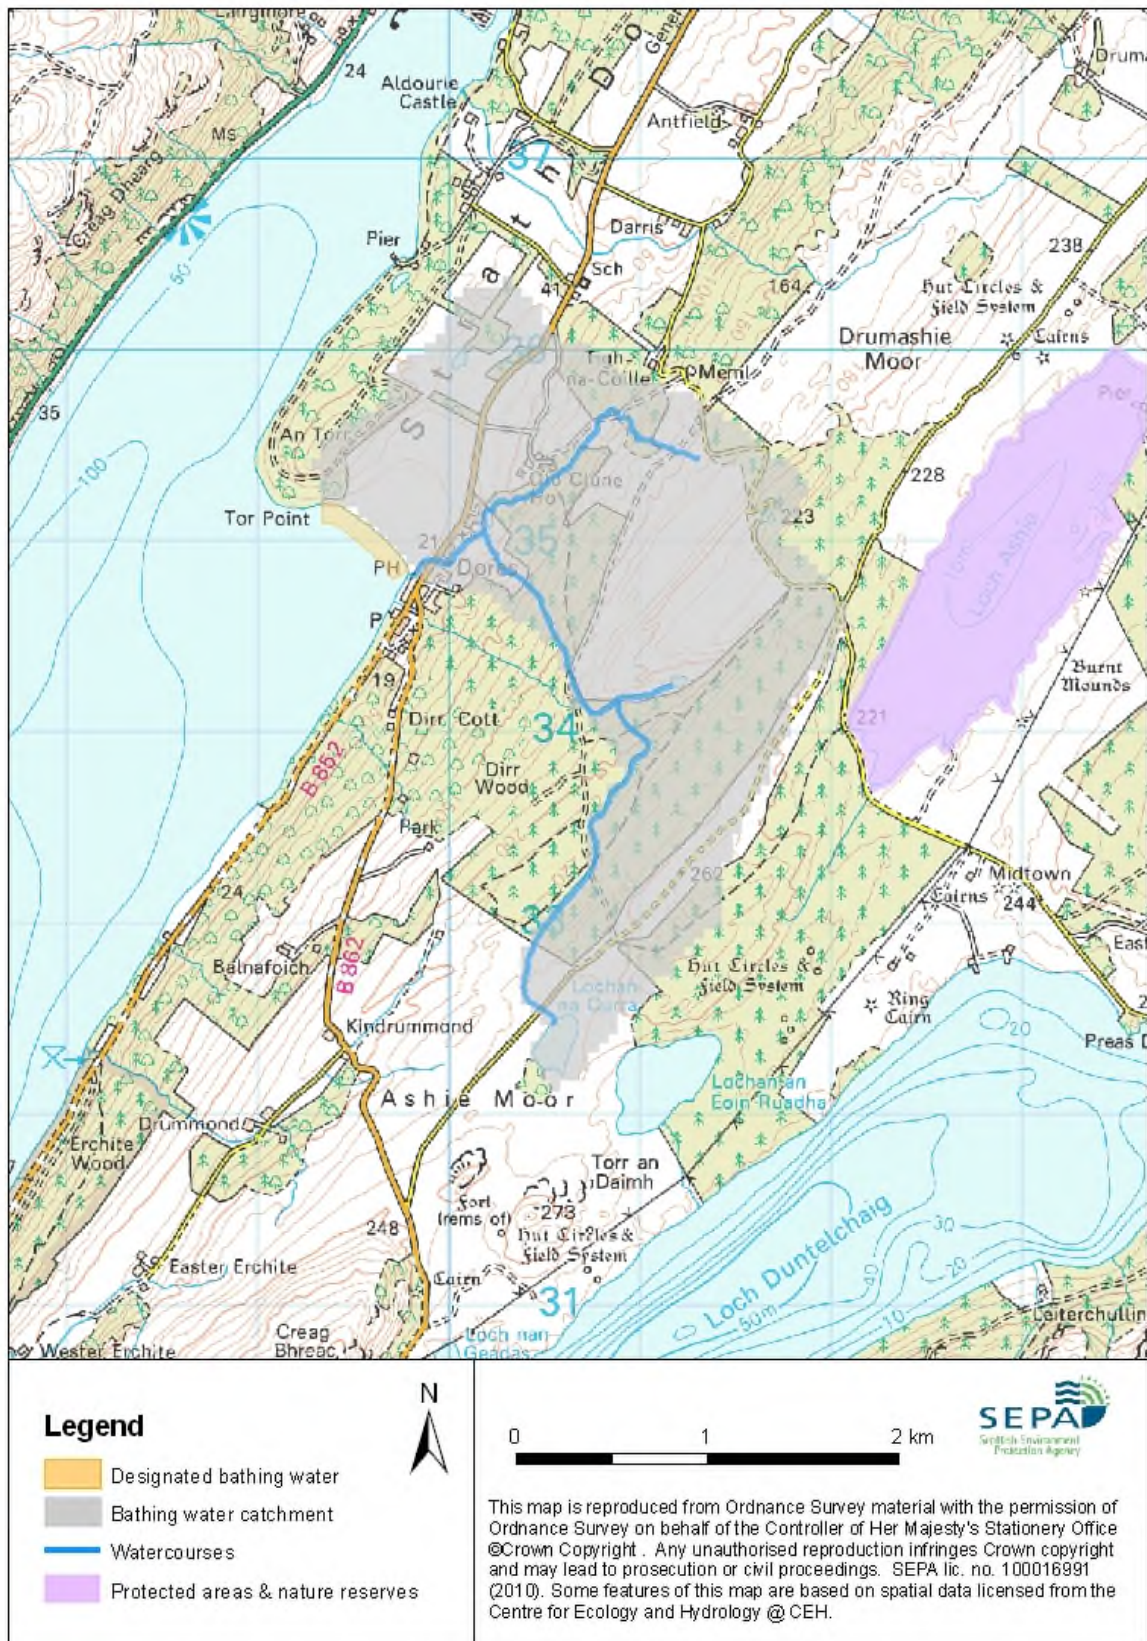
Map 2: Catchment draining into Dores bathing water

The catchment draining into the Dores bathing water extends to 5 km². The catchment is steep in topography ranging from hills in the south and east to the lower lying parts along the loch.

The main rivers within the bathing water catchment are the Allt a' Mhinisteir and Dores Burn. The Allt a' Mhinisteir is the only water course feeding directly to the designated bathing water. The Dores Burn flows in just beyond the eastern end of the bathing area.
